Waterfront Parks Master Plan

Part 2 (Zones 6-13)

Maskinonge River
Claredon Beach Park
Rayners Park

The Planning
Partnership

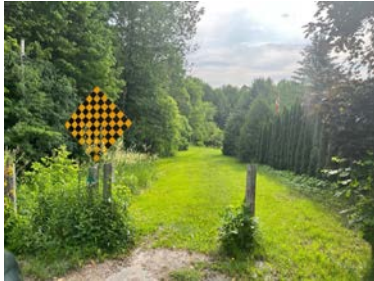
Category 1:

Appears to be open to all. Grass is cut, obvious signs of use, sometimes there's a way to get canoes/kayaks in the water. Morning Glory and Port are examples

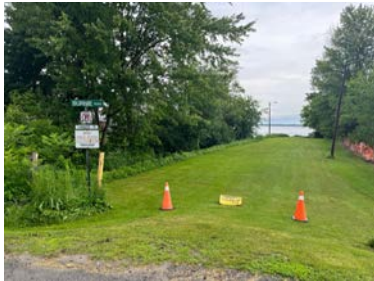
Category 2:

Currently signed as “no public access”, "private", or for members of a residents group or Beach Association only, maintained by Town, Beach Association, residents groups or adjacent residents

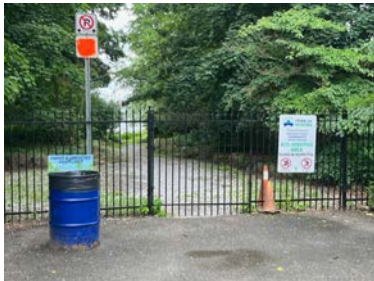
Category 3:

A partnership with the Town and the cottage/community association (Roches Point seems to be the only example)

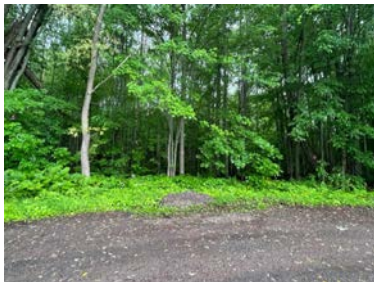
Category 4:

Currently, inaccessible by foot (ie no clearing for trail or ATV)

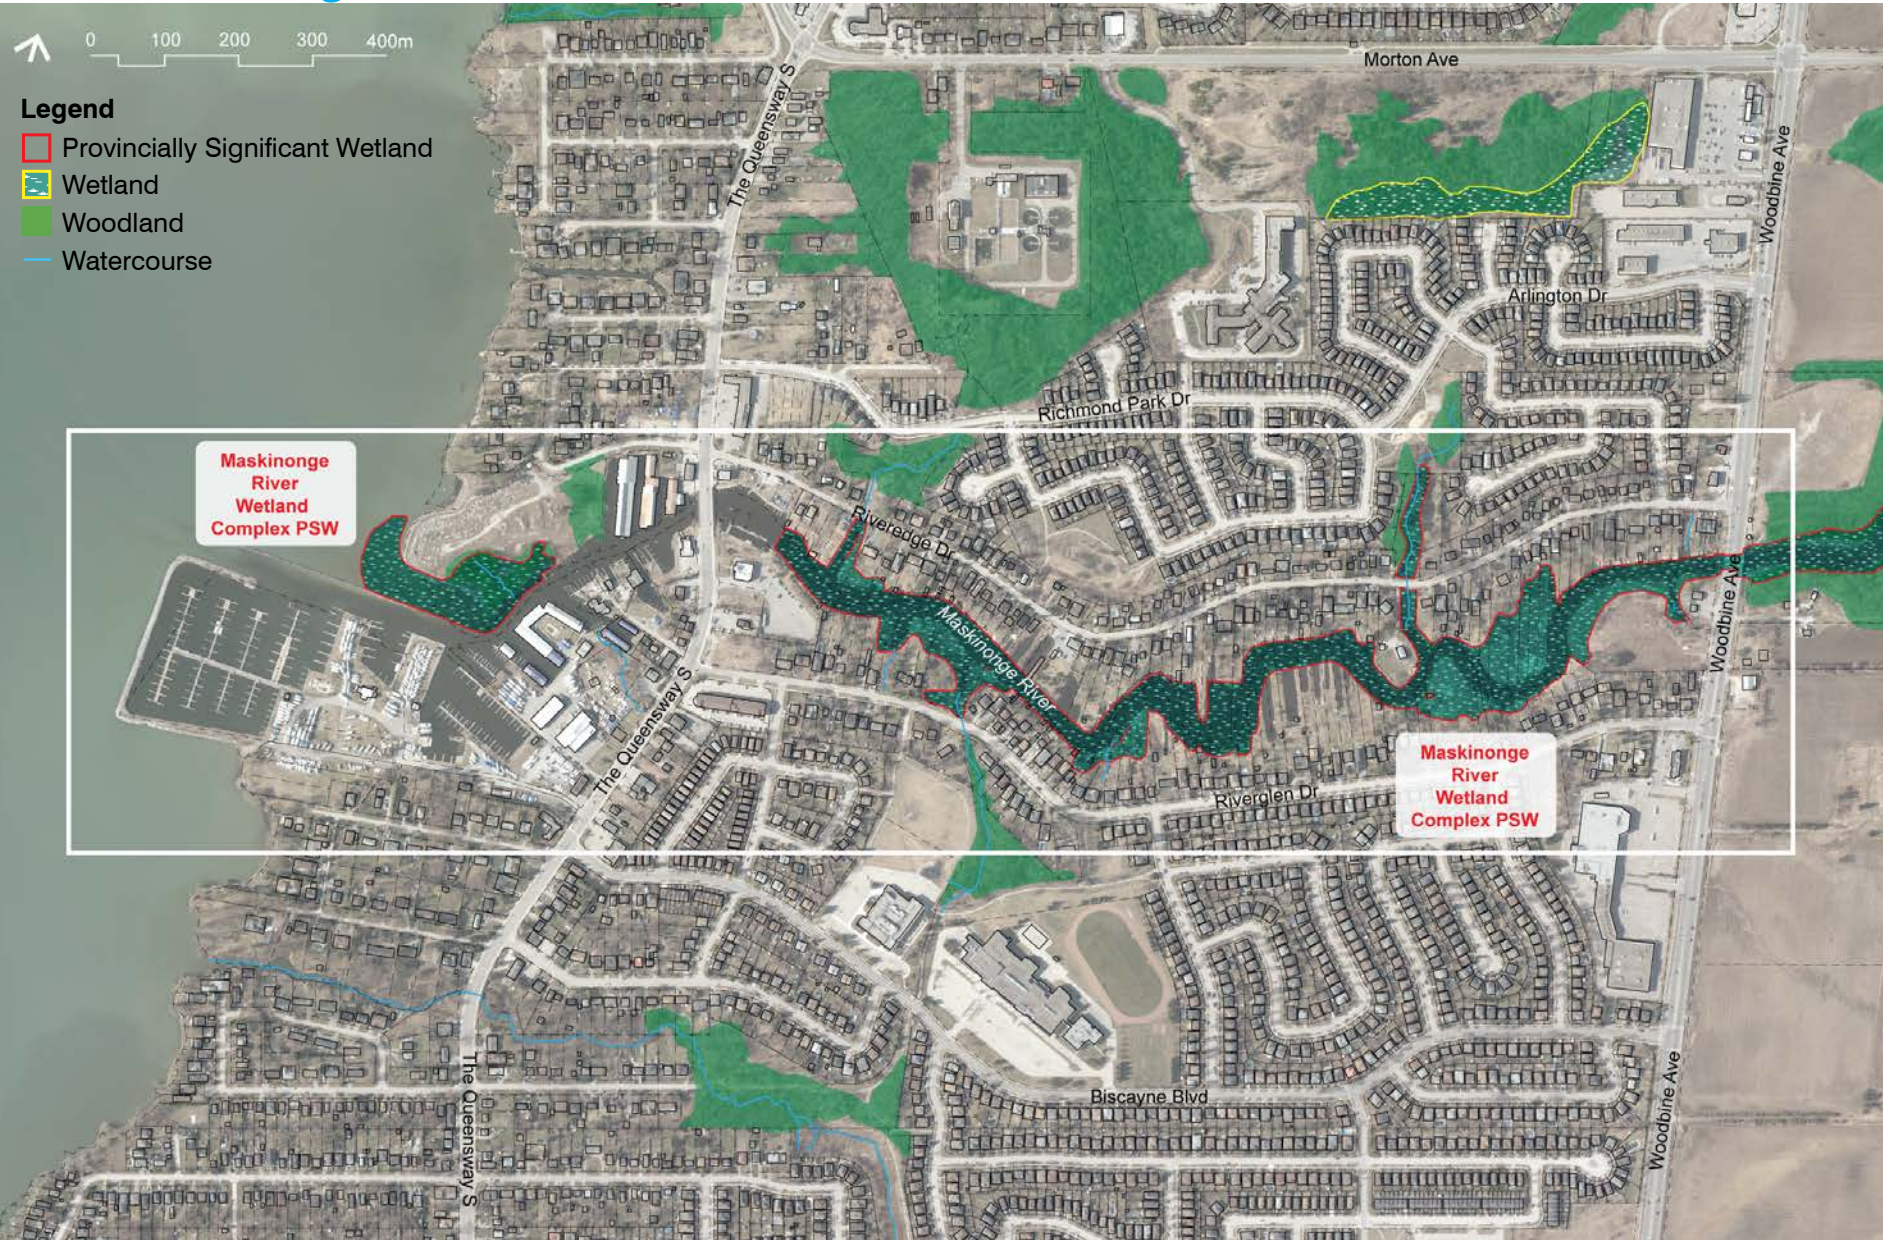
Natural Heritage

- Maskinonge River Provincially Significant Wetland Complex associated with riparian zone and flood prone areas. Mosaic of marsh (cattail, phragmites, reed canary grass), thicket swamp (red-osier dogwood/willow) and deciduous swamp (silver maple, green ash, poplar, willow).
- High level of habitat disturbance and degradation. Limited amount of riparian habitat.
- Water quality issues related to upstream agricultural land use and water-taking for crop irrigation. Excessive growth of algae and aquatic plants (e.g., duckweed) in the river channel.
- Remnant forest with watercourses located north of Riveredge Drive.

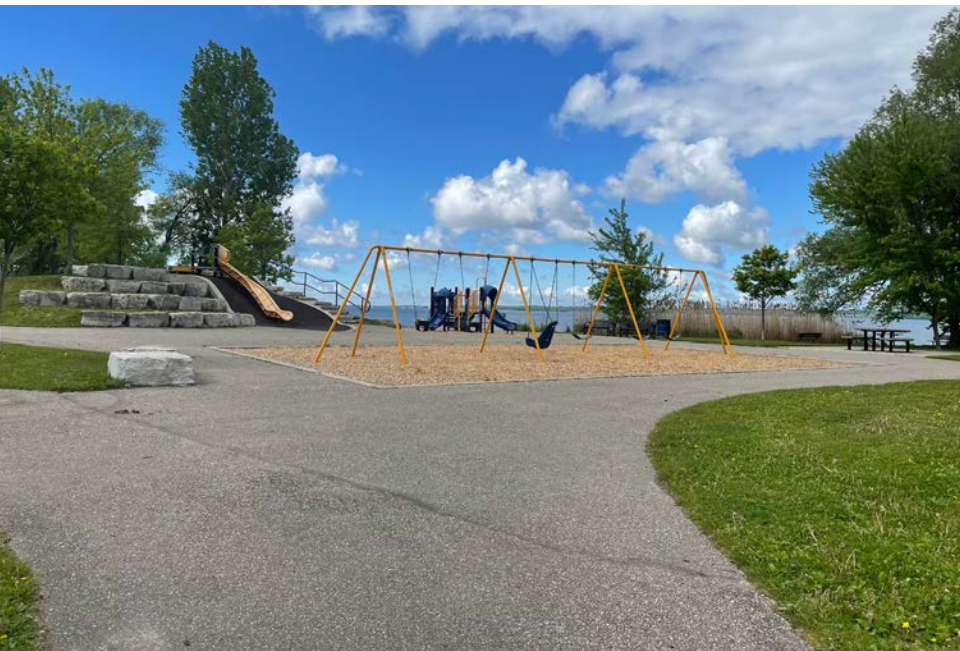
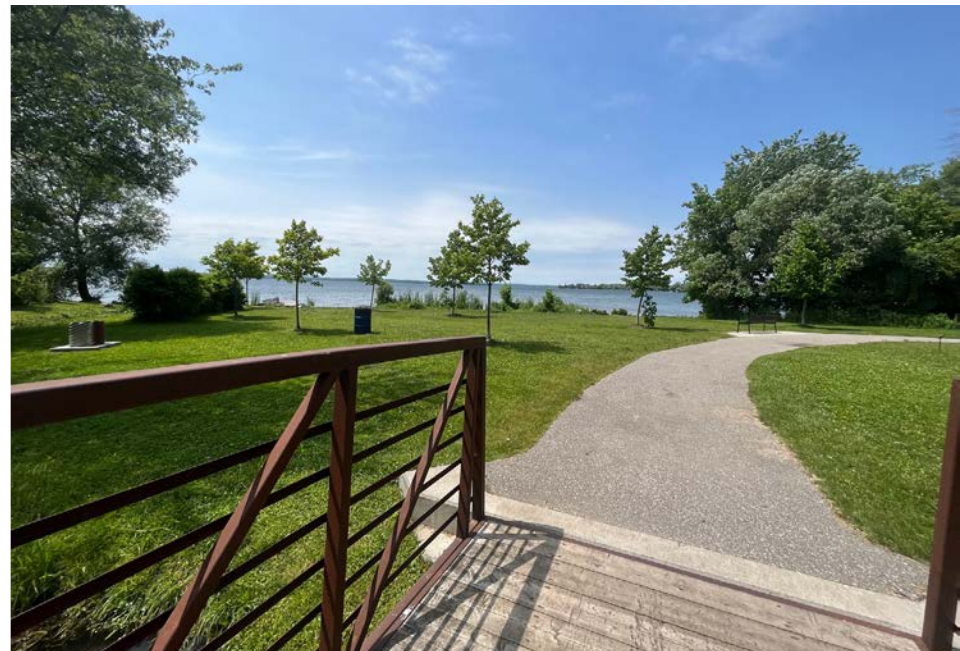
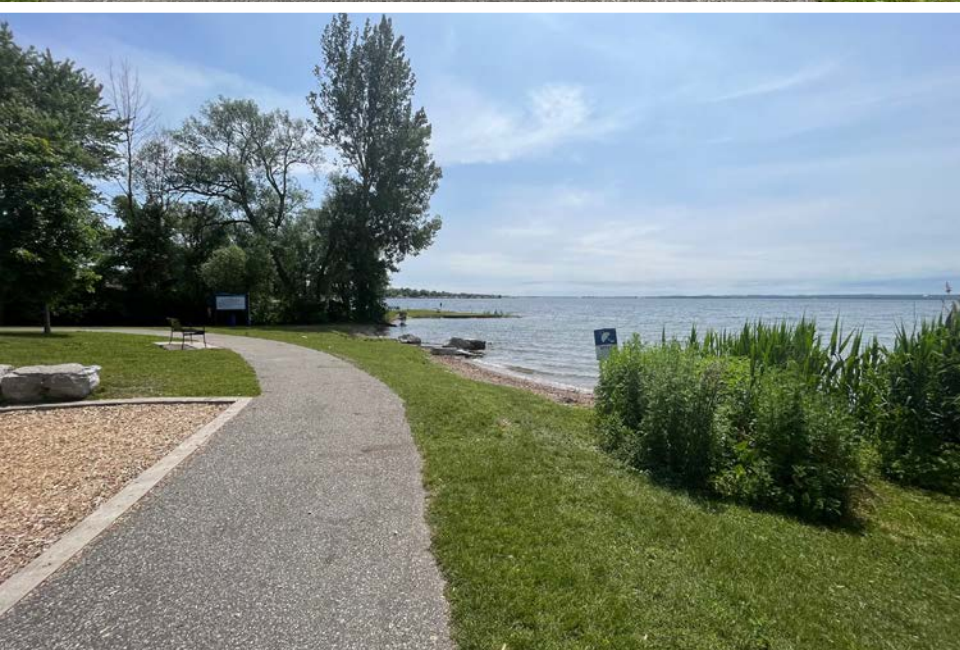
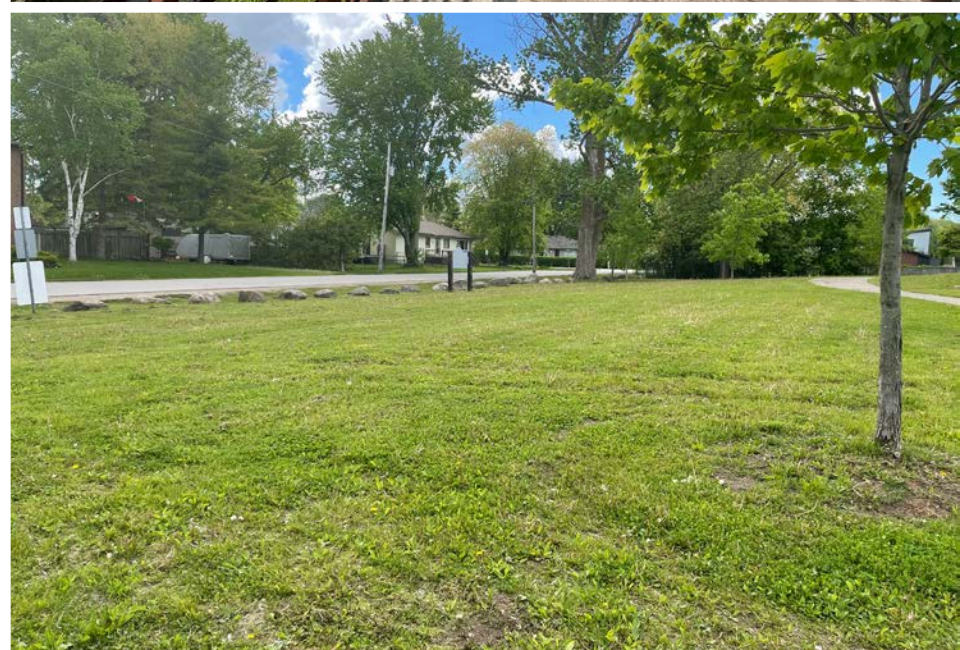
Claredon Beach Park

- Park on open shore exposed to Lake Simcoe wave action.
- Shoreline protected with boulders, armourstone, there is evidence that stone has shifted, possibly due to ice.
- Cobble nearshore.
- Evidence of limited erosion along backshore of protected shorelines.
- Creek drains through park.
- Beach area at south end of park, sand covered in Phragmites debris.

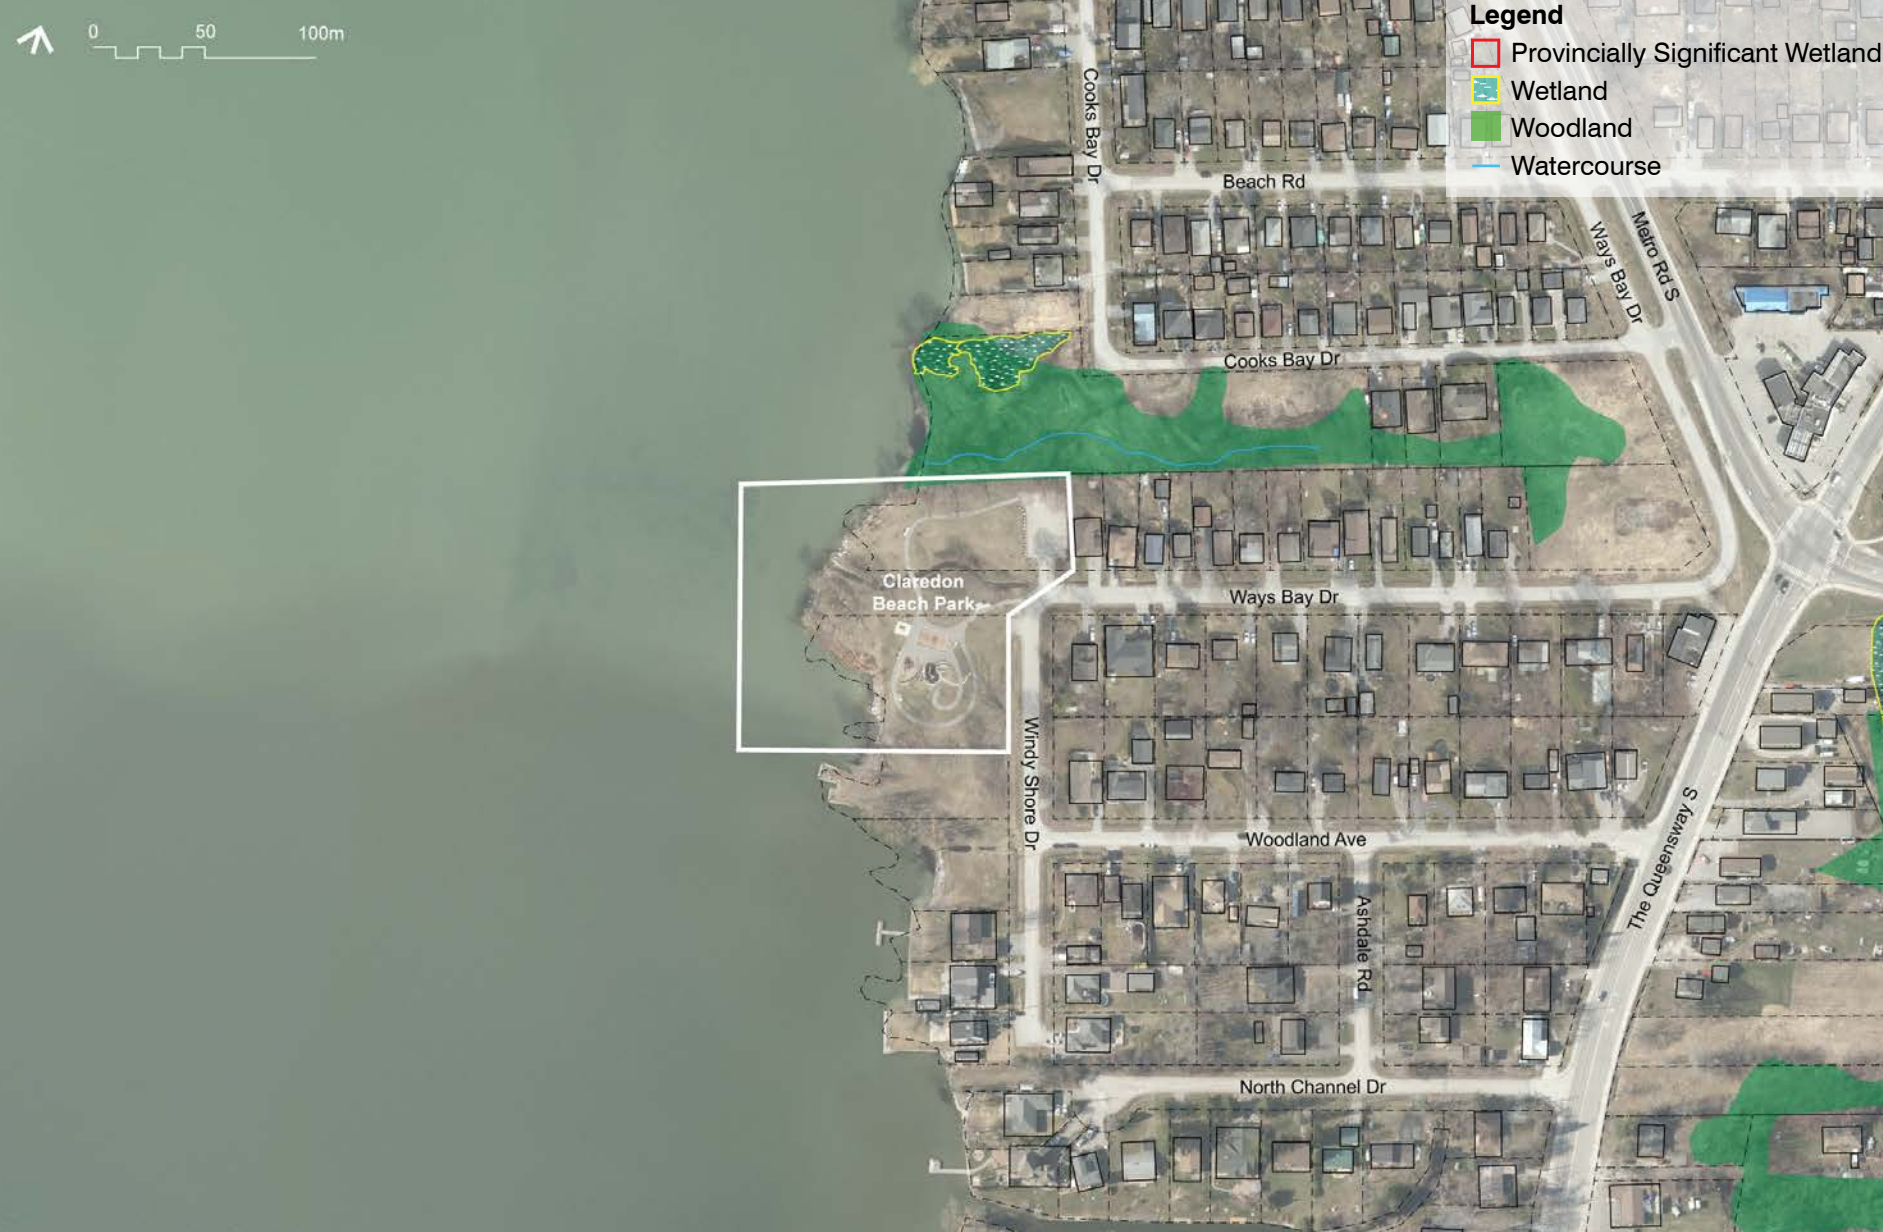
Natural Heritage

- Manicured grounds with willow, red/silver maple, Manitoba maple, eastern white cedar, brambles, red-osier dogwood, grey dogwood, reed canary grass, phragmites, cattail, and asters/goldenrods.
- Narrow fringe of shoreline vegetation.
- Small creek (road drainage) within the park supports baitfish.
- Shoreline protection – armour stone, beach stone.
- Windsurfing and para-sailing launch point.

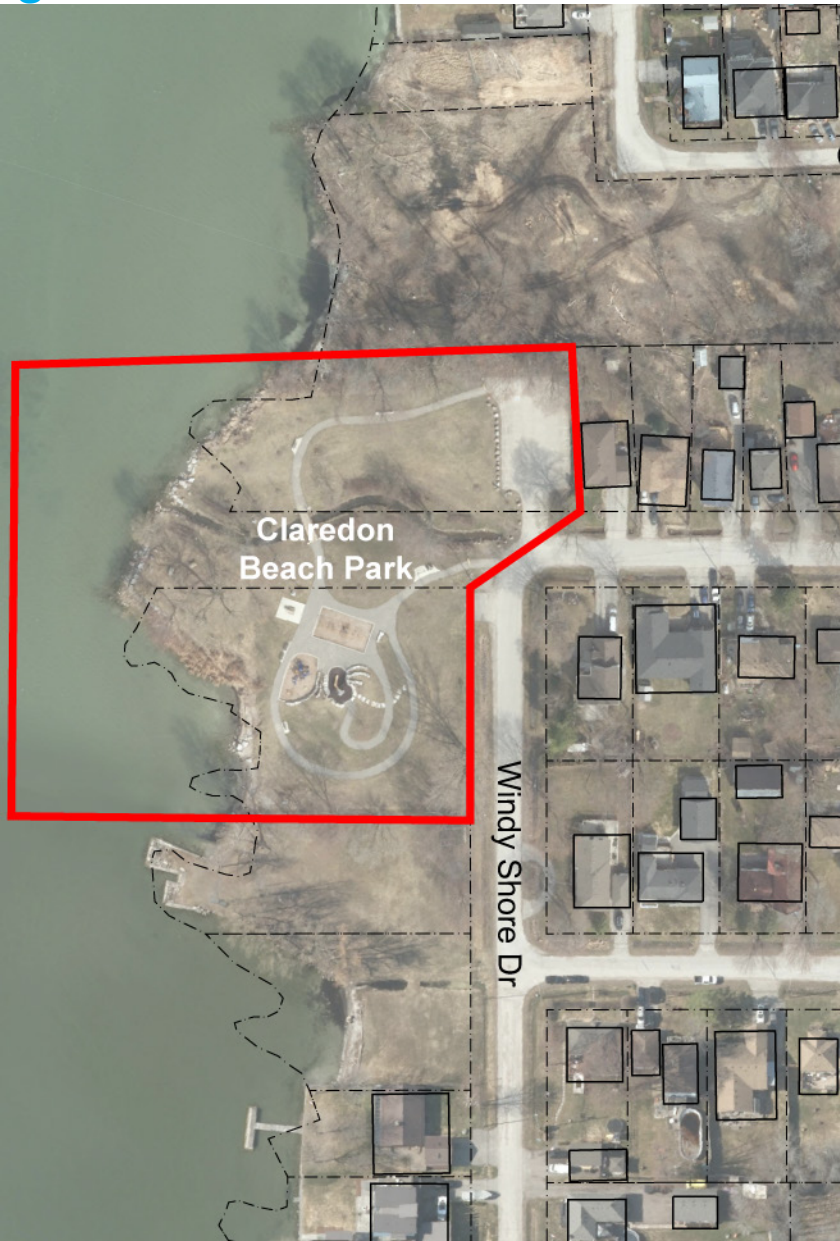
Early Thoughts

- create designated locations for snowmobile/ATV access to the lake, in conjunction with shoreline improvements.
- pedestrian connection north to Cooks Bay Drive

- incorporate bio-swale plantings within the creek (at the culvert) to polish/filter road runoff before it enters the lake.
- augment existing shoreline vegetation with locally indigenous plant species
- a 1-2m wide “no mow” zone along shoreline to increase habitat and promote stabilization
- monitor armourstone, field stone protection for damage
- clean Phragmites from beach

- consider installing an osprey platform
- accessible surface in play ground

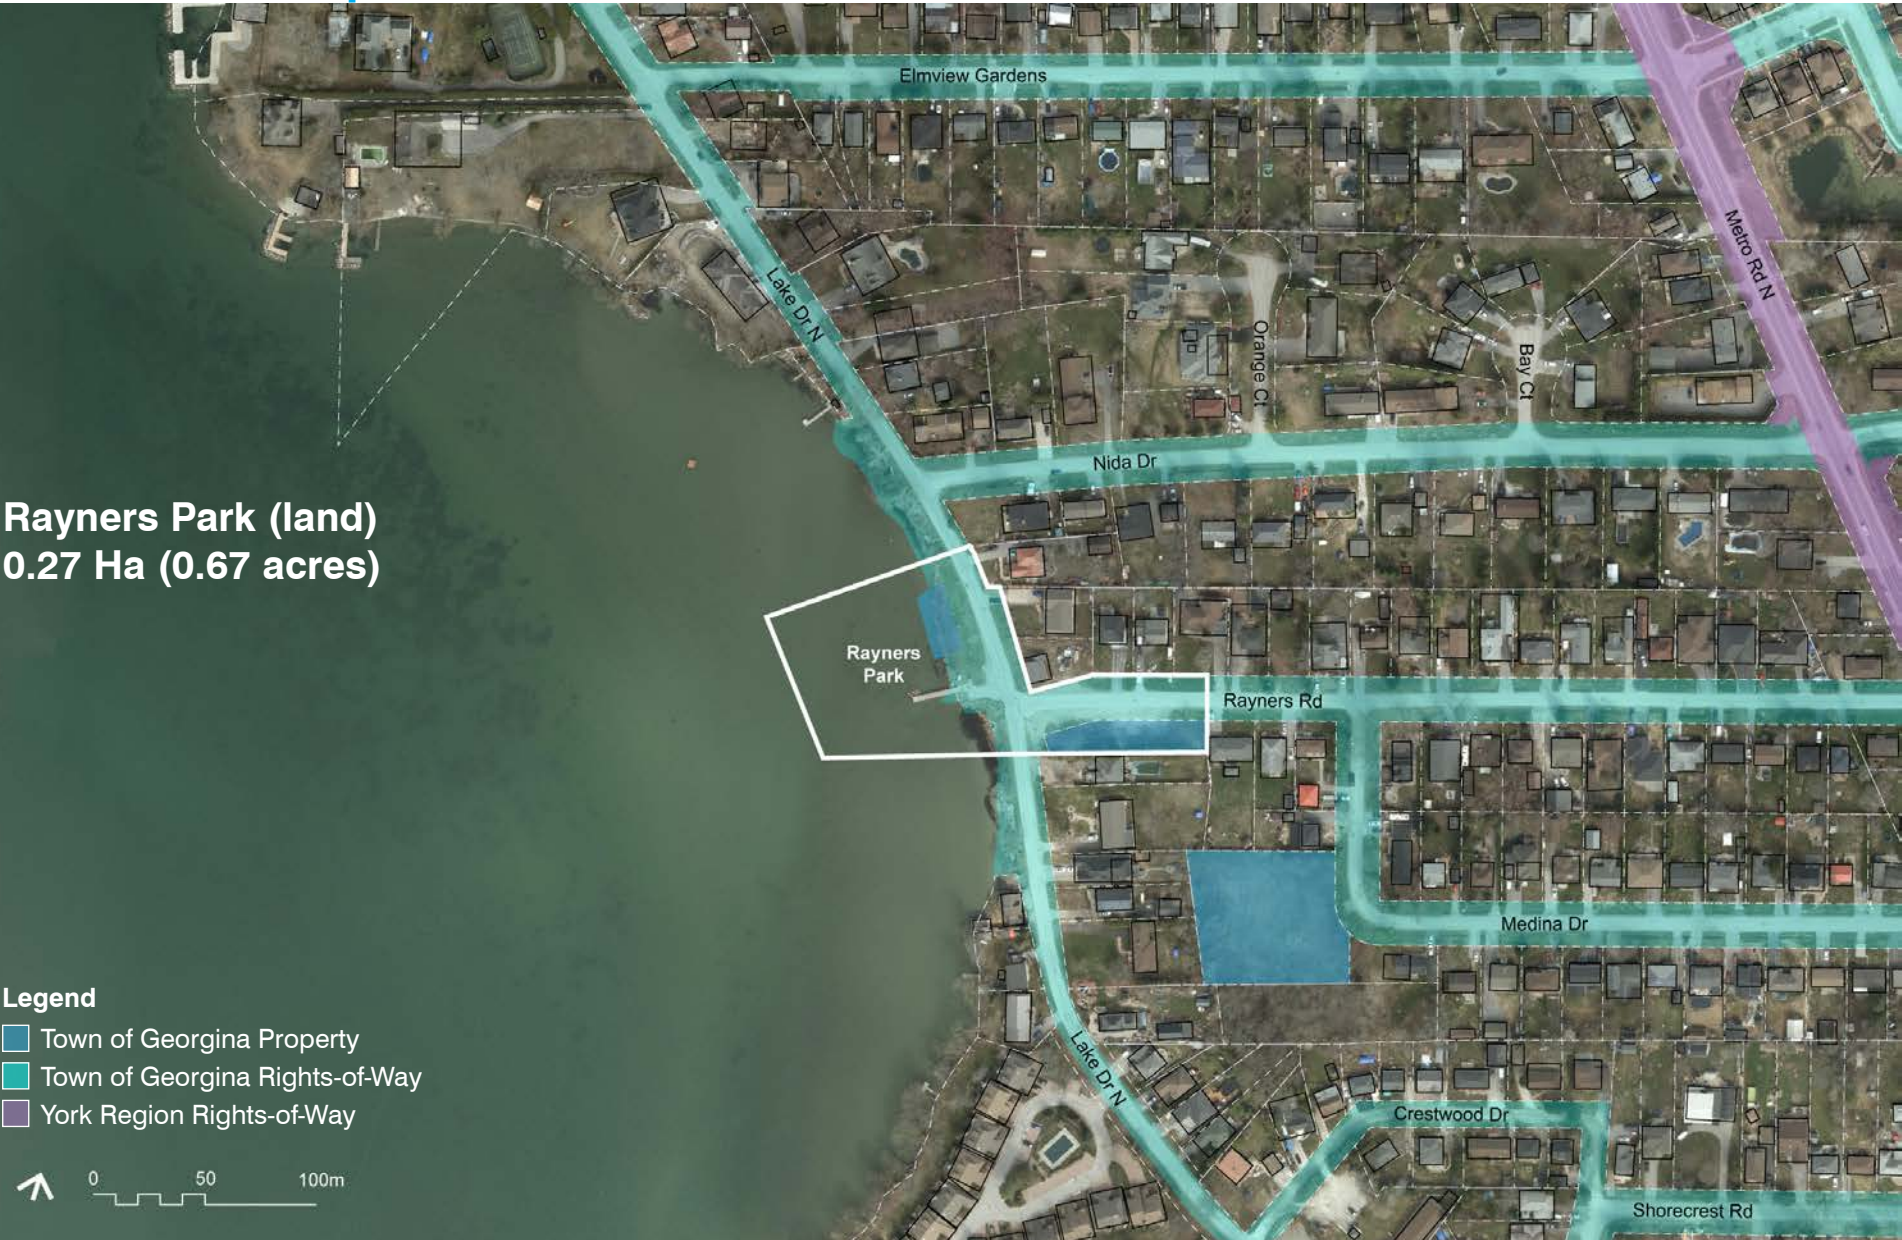
Land Ownership

- Town of Georgina Property
- Town of Georgina Rights-of-Way
- York Region Rights-of-Way

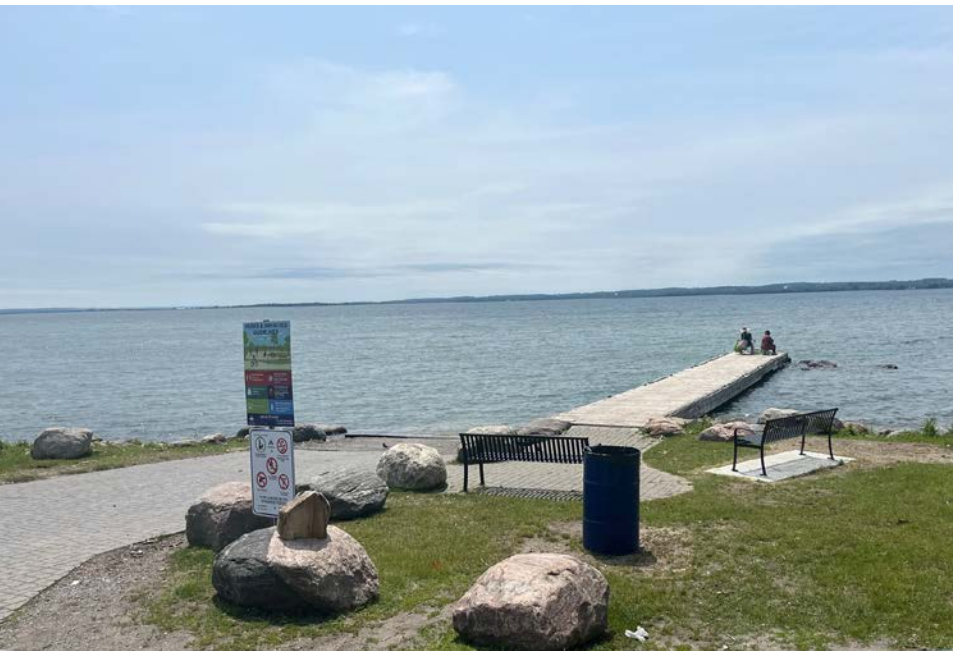
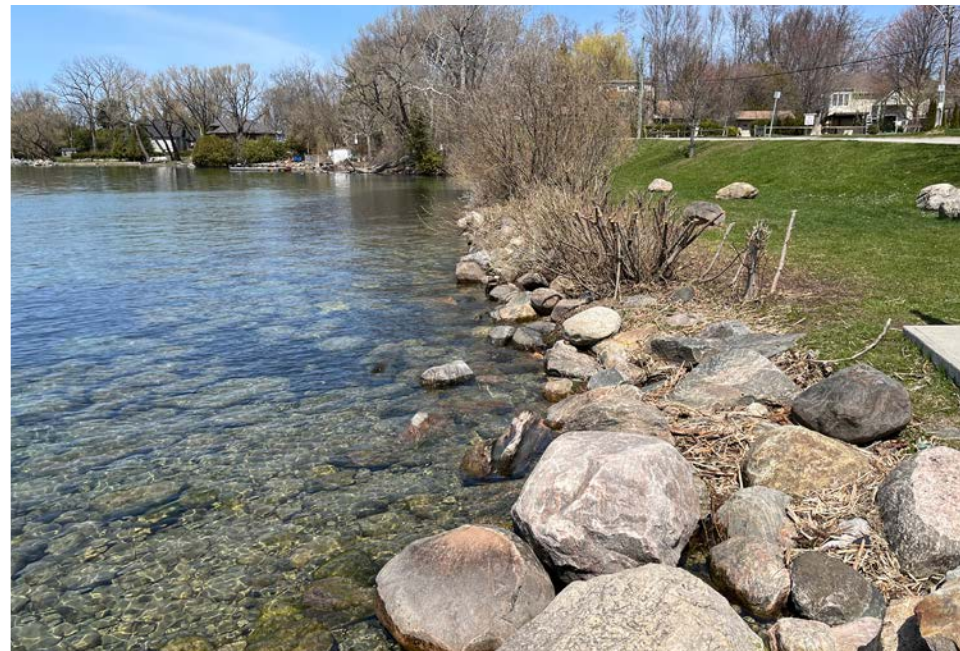
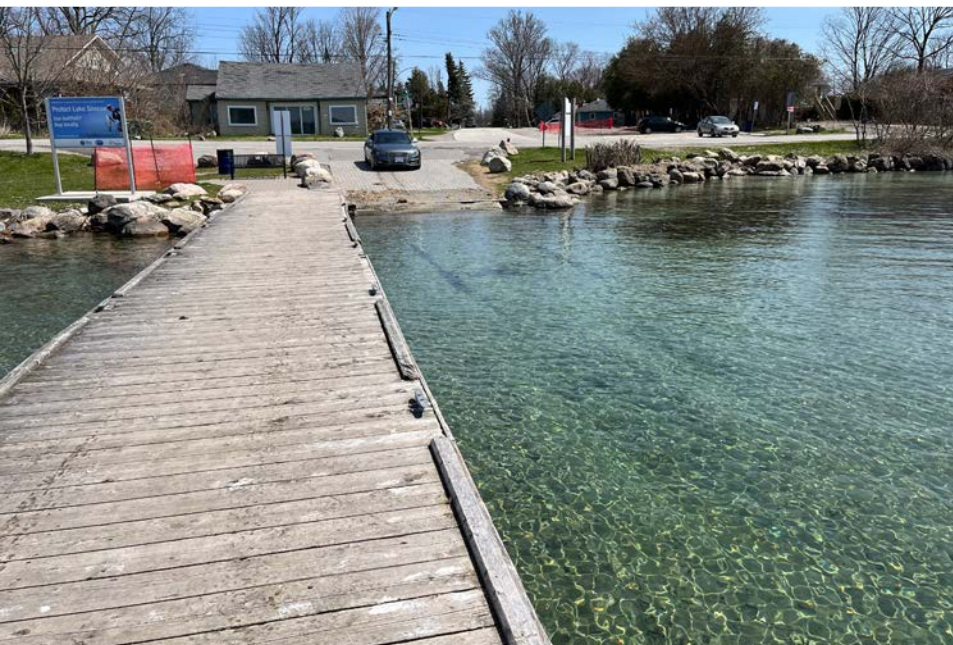
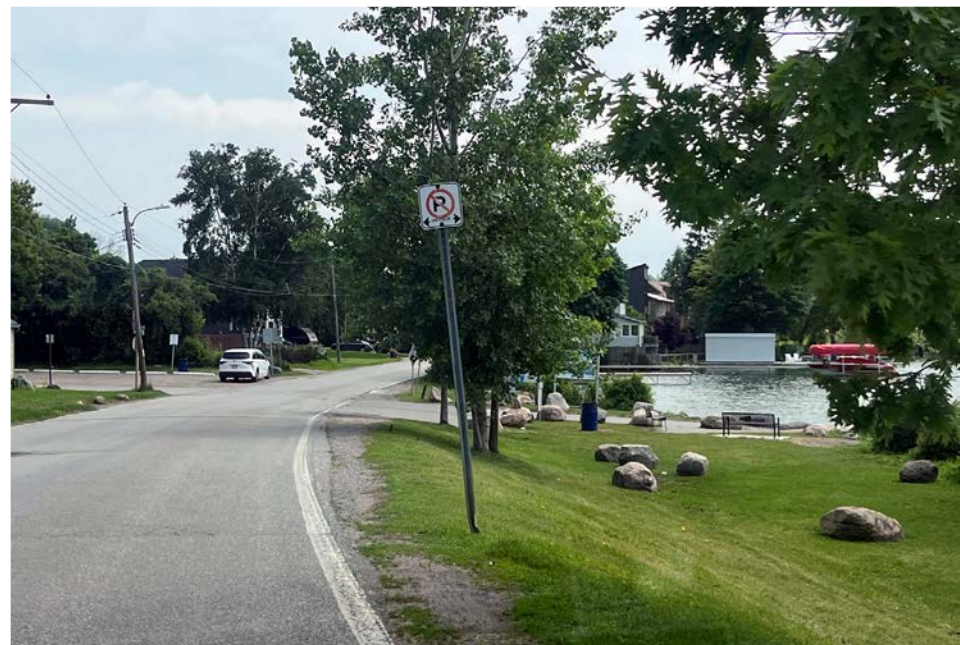
Rayners Park

- Shoreline on open lake exposed to Lake Simcoe wave action, ice.
- Shoreline north of boat launch protected with boulders, plantings.
- Pile supported dock, boards rotted in places, boulders in near shore prevent use of north side of dock.
- Boat launch, concrete slabs.
- Concrete damage, exposed rebar.

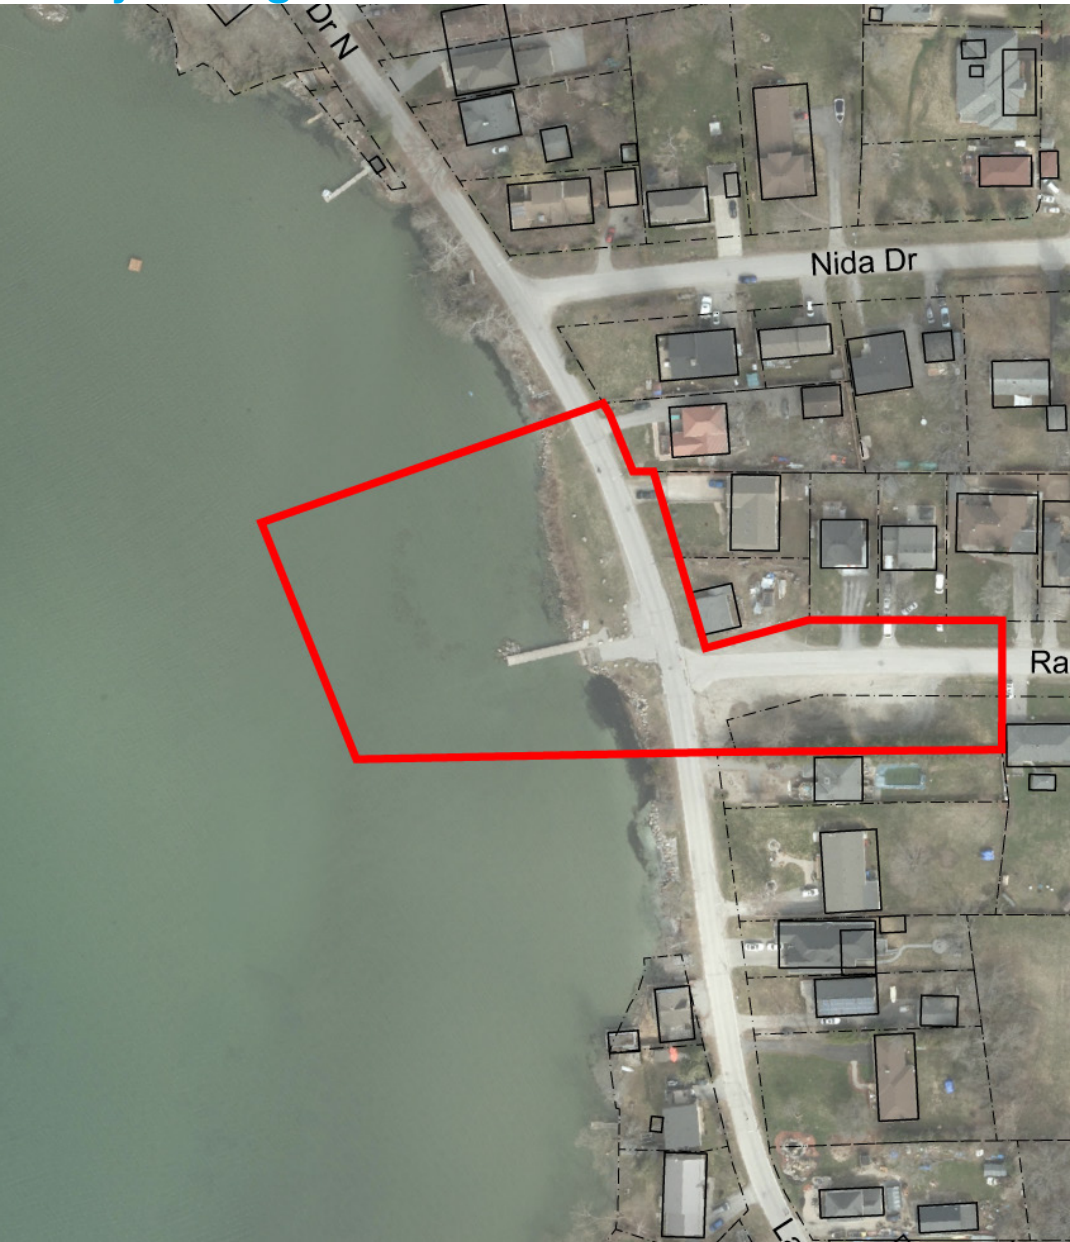
Early Thoughts

- expand and define parking
- pedestrian walkway on Lake Drive

- augment existing shoreline vegetation with locally indigenous plant species – selective plantings to compliment previous restoration project.
- consider bio-swale opportunity to polish/ filter road runoff from Lake Drive, Rayners Road, and the parking area.

- opportunity for complimentary use in opposite building on the corner
